DESCRIPTIVE REPORT

Type of Survey ... Wire Drag
Field No. R/H-40-3-73
Registry No. FE-337WD

State Louisiana--Texas
General Locality ... Gulf of Mexico
Sublocality Sabine Bank

HYDROGRAPHIC TITLE SHEET

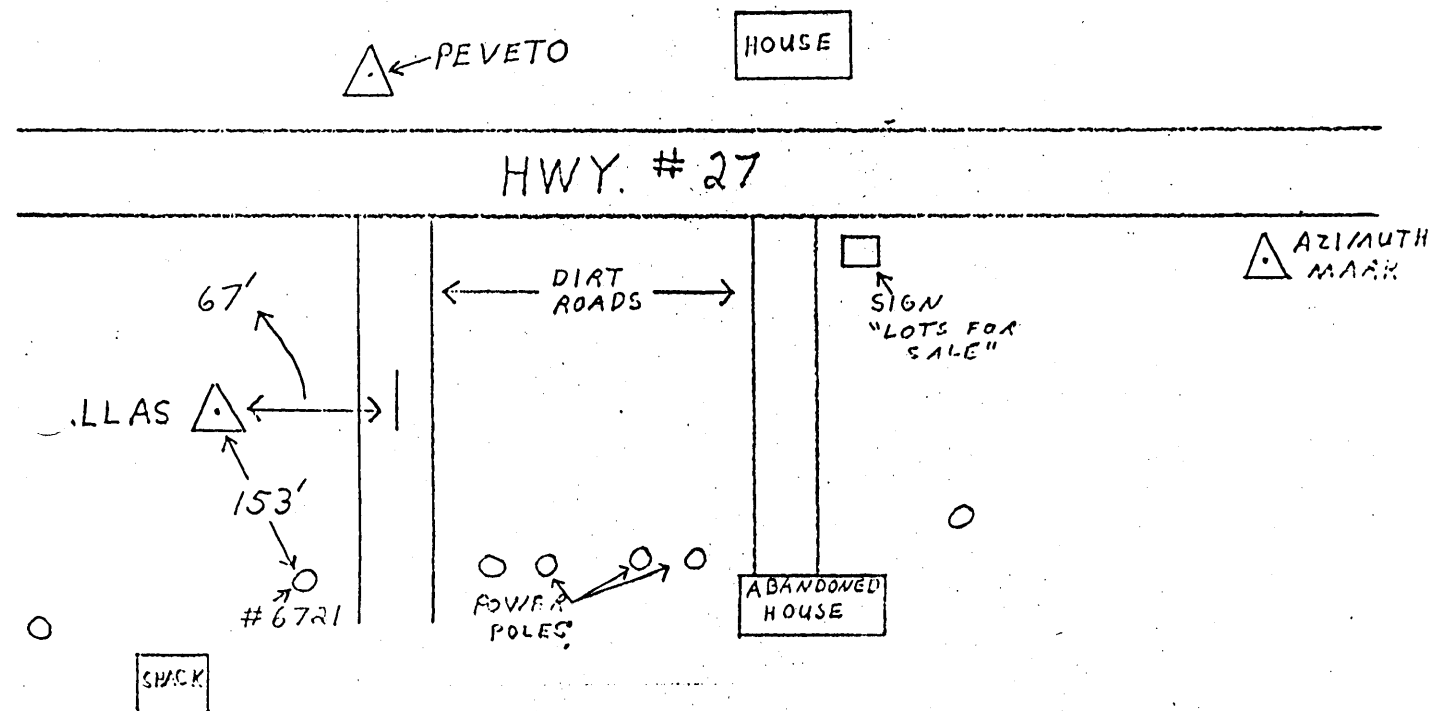
"DALLAS STATION"

DALLAS station is located about 8 miles east of Johnsons Bayou School off of State Highway 27. It is marked by a metal stake driven into the ground with orange colored bunting wrapped around the top.

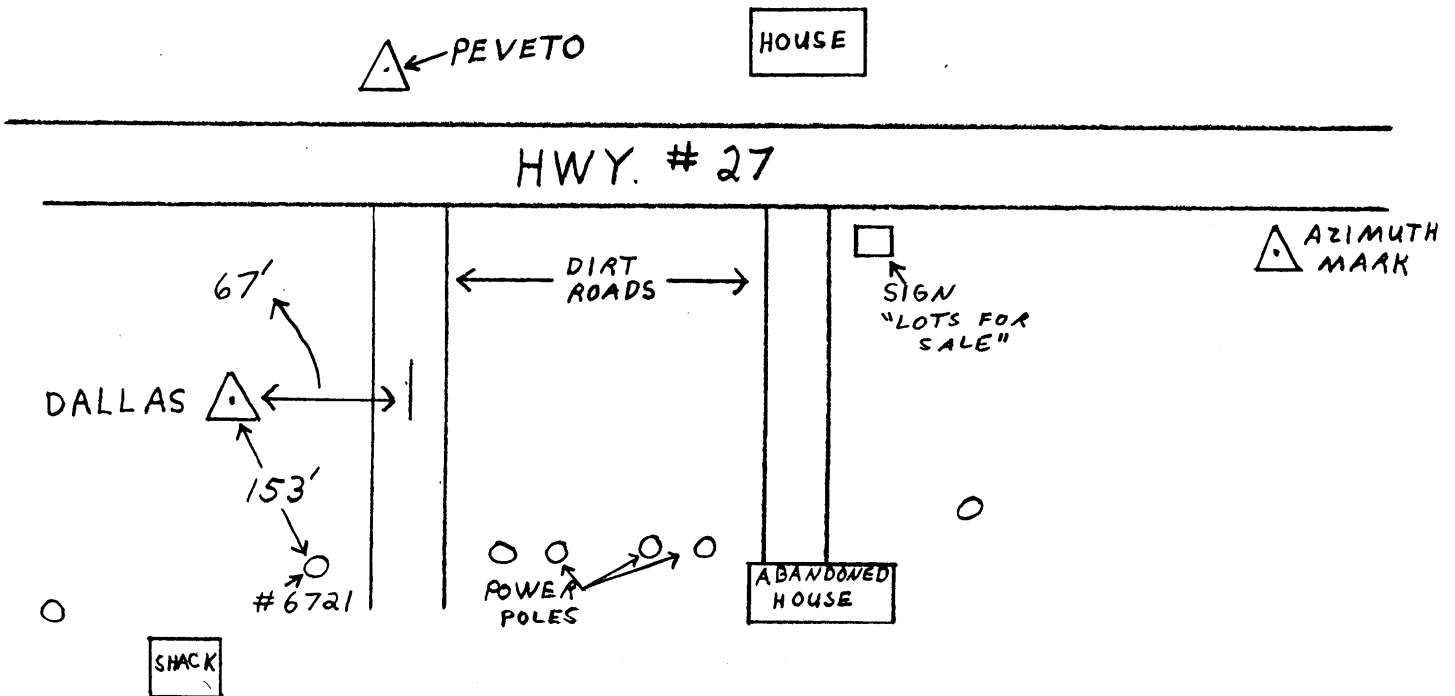
"DALLAS STATION"

A. Land is owned by Dallas Dominique and we have his permission to use the land. His address: Rt. 1 Box 250
Cameron, Louisiana 70631
Phone: LI2-8134

B. We hook in for power on pole #6721, JDE CO-OP: 42 065 960. The meter on the pole is owned by R.D. Spelman and he had given us permission to use it. We reimburse him for the power we use.
His address: 1724 Williams Circle
Sulfur, Louisiana 70663
Home phone: 318-625-3175
Bus. phone: 318-491-7300

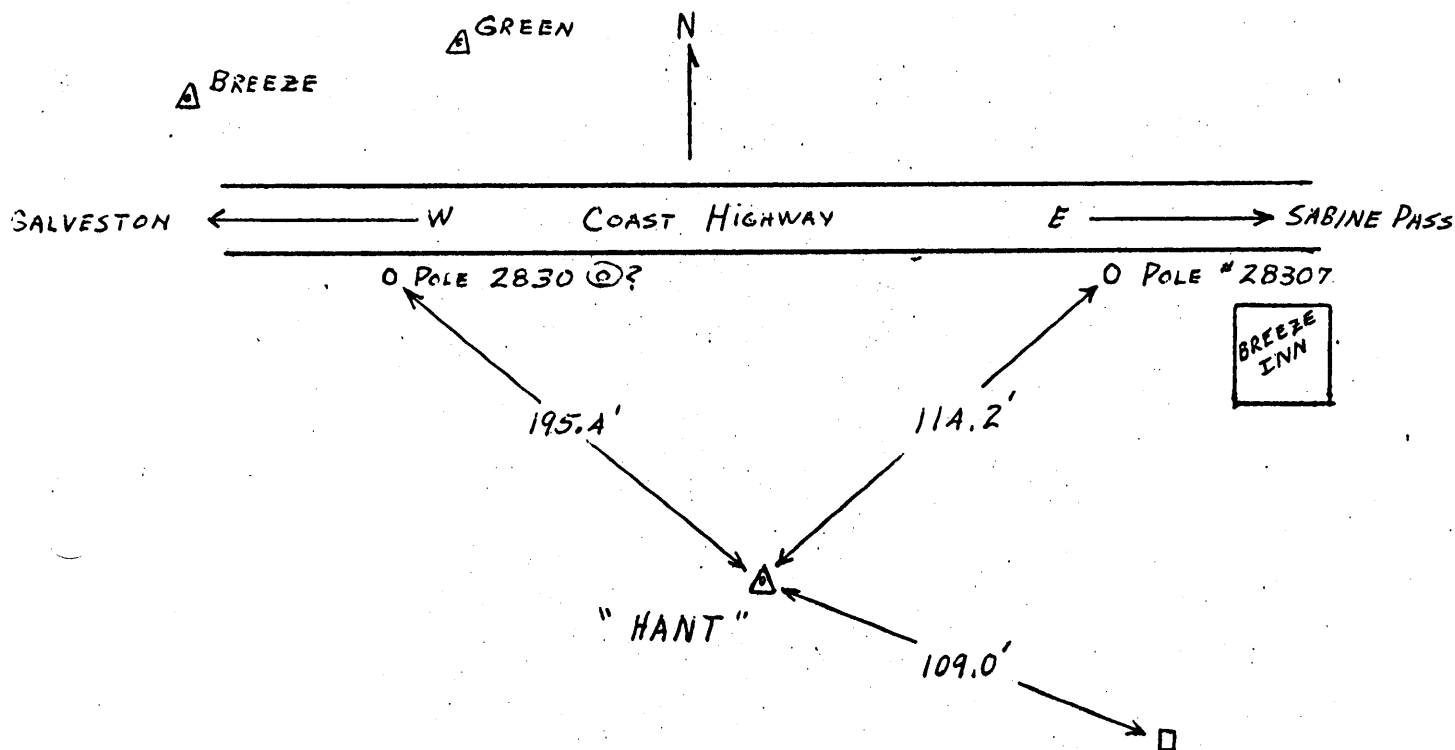
This station is located near the Breeze Inn, just off the Coast Highway between Galveston and Sabine Pass.

It is marked by a metal stake driven into the ground with orange colored bunting wrapped around the top, and can be reached by referring to the station description for GREEN.*

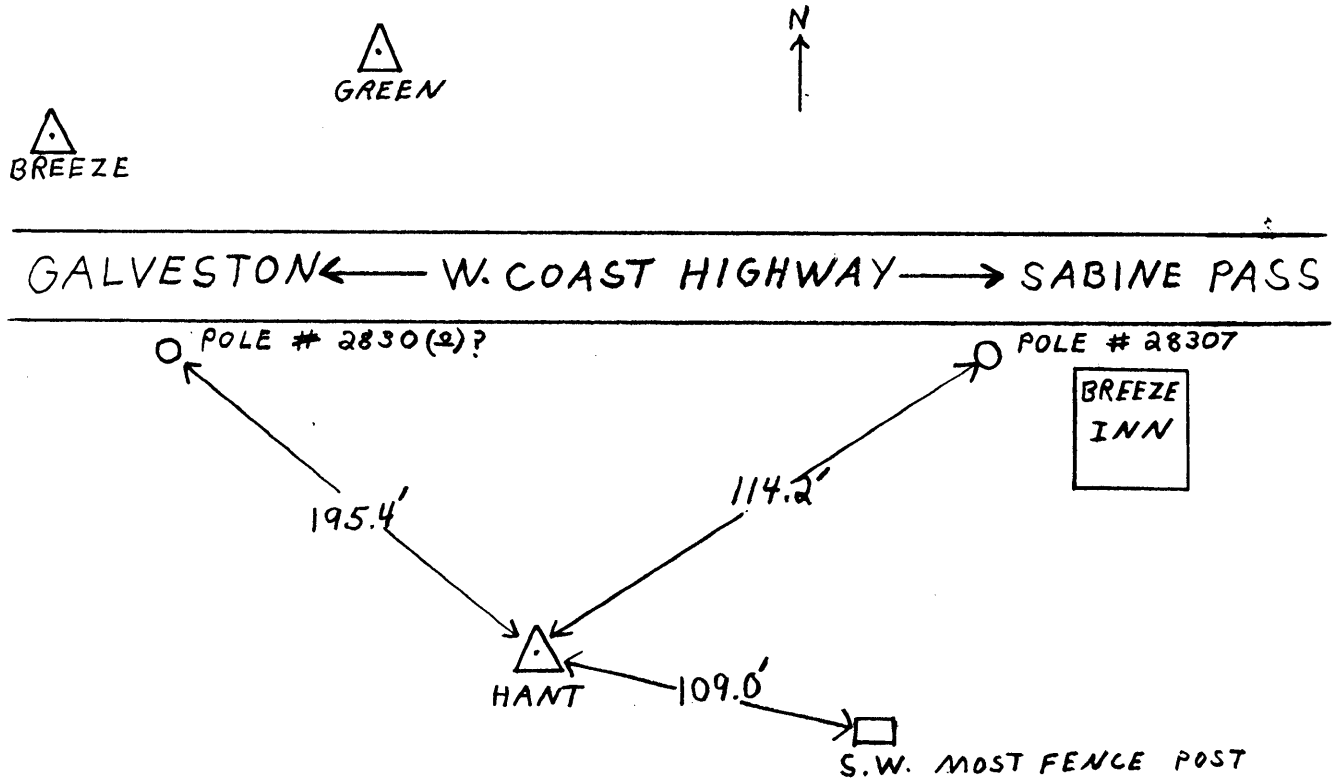
"STATION HANT"

- A. Station HANT is marked by a metal stake with orange bunting tied on the top.
- B. Contact the owner of the "Breeze Inn". He will supply you with the electric power needed to run the station for a nominal fee.
